CHRISTIANSSEN LAKE DAM

JACKSON COUNTY, MISSOURI

MO 20145

**PHASE 1 INSPECTION REPORT
NATIONAL DAM SAFETY PROGRAM**

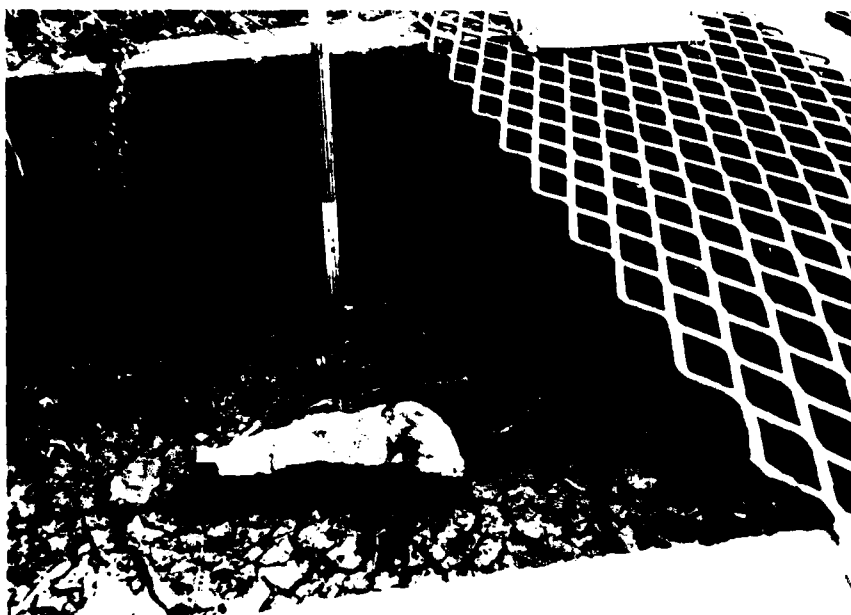
(1) The principal spillway is in a deteriorated condition. The lake level at the time of the inspection (El.927.7) was below the inlet level however, there was a small amount of flow from the pipe outlet. Only the inlet and outlet ends were observable. The spillway pipe discharges with a free outfall into an eroded hole at the inlet to two 66-inch pipe under Moreland School Road. Flow from the principal spillway would not be hindered by obstructions in the downstream channel.

PHOTO 6: PRINCIPAL SPILLWAY PIPE INLET END

(4) The principal spillway pipe should be repaired.

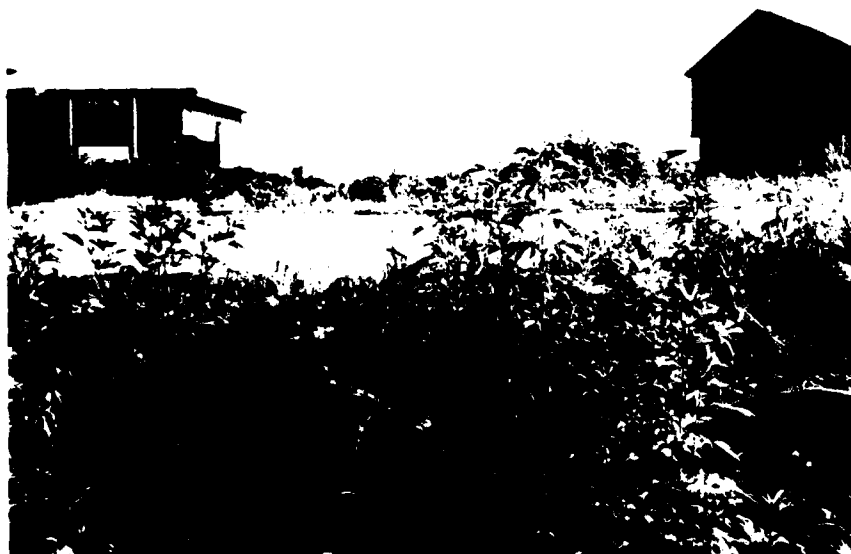
PHOTO 8: CULVERT UNDER MORELAND SCHOOL ROAD
BELOW PRINCIPAL SPILLWAY OUTLET

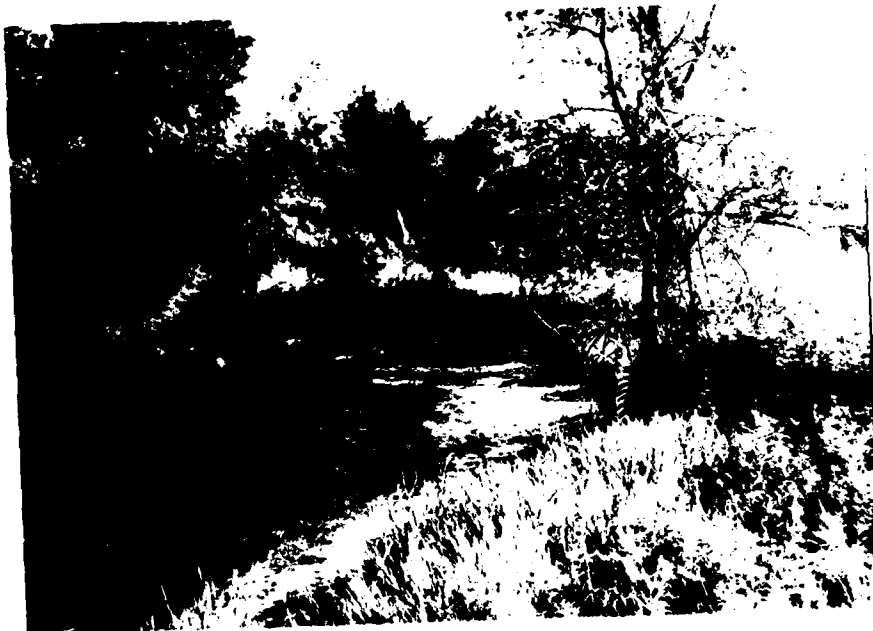
(2) The emergency spillway channel is poorly defined but shows no evidence of erosion. The emergency spillway channel is lined with extremely dense and tall grass. Growth of trees and brush in the spillway channel will cause some restriction to flow.

PHOTO 9: EMERGENCY SPILLWAY

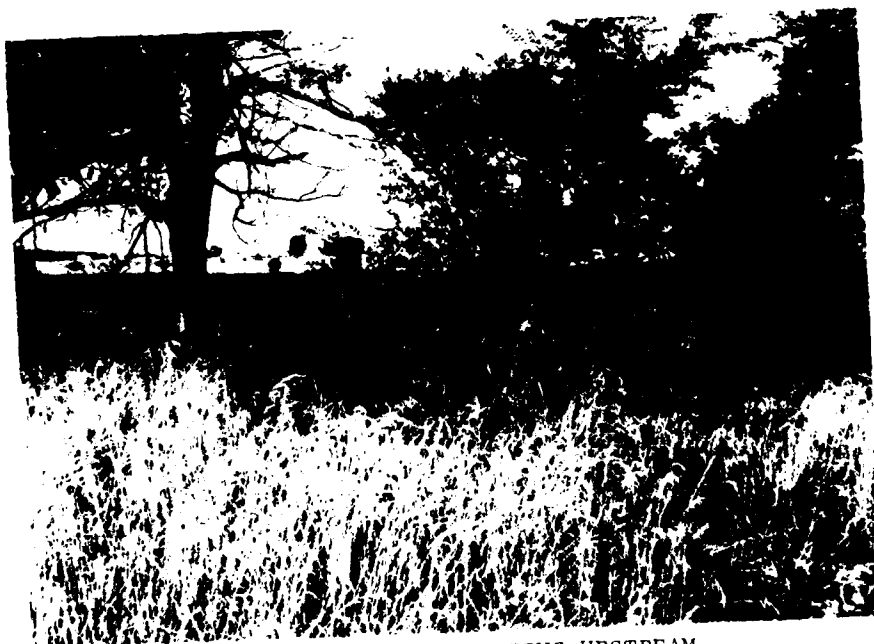
PHOTO 10: EMERGENCY SPILLWAY LOOKING UPSTREAM

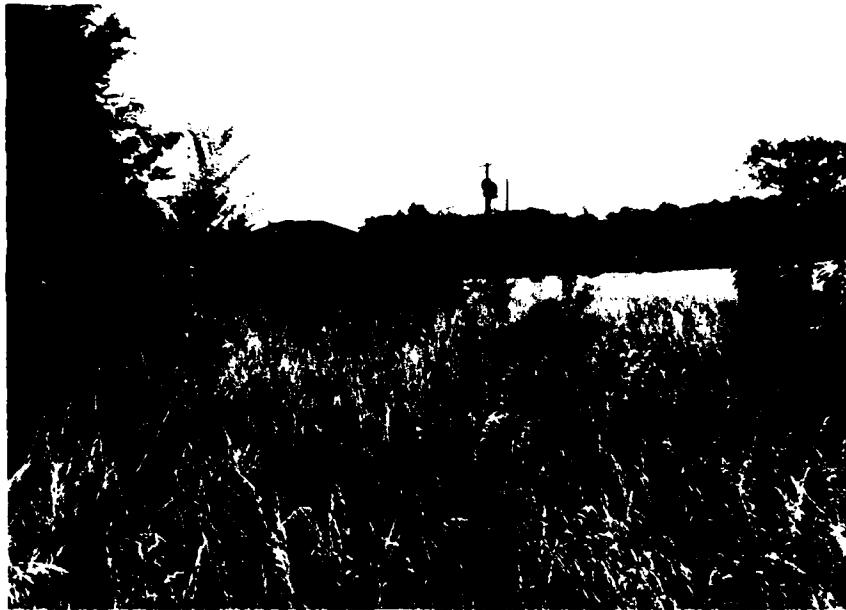
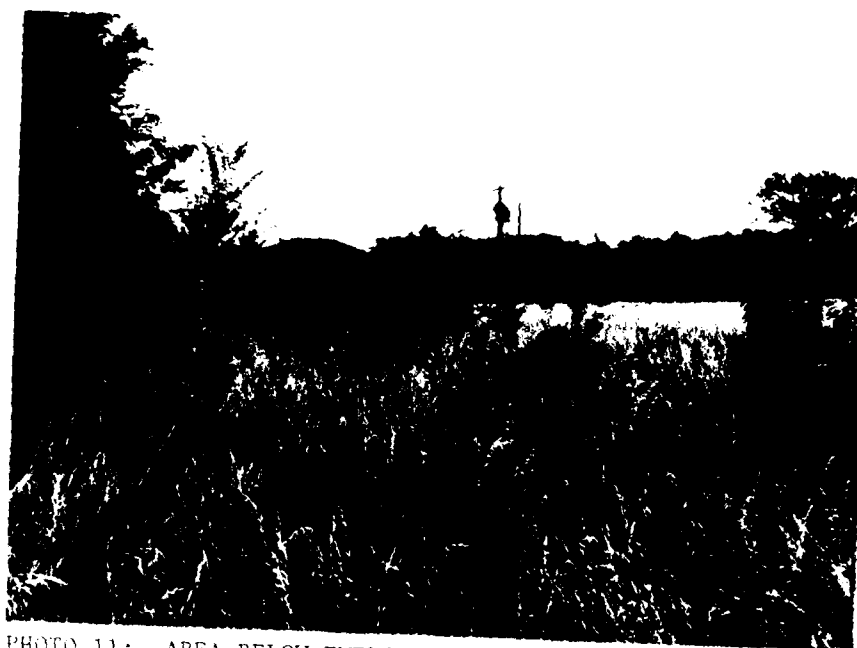
PHOTO 11: AREA BELOW EMERGENCY SPILLWAY LOOKING DOWNSTREAM
